# DDASaccident560

# DDAS Accident Report

Subject: REPORT ON [foreign] EOD TEAM ACCIDENT 25-07-2007

On the 25th July 07 a [European] EOD team suffered an explosion in the vicinity of Shama at UTM 704664-668268, resulting in the death of one [European] NCO. After receipt of initial reports to JOC, the incident was investigated. This report outlines the results of that investigation.

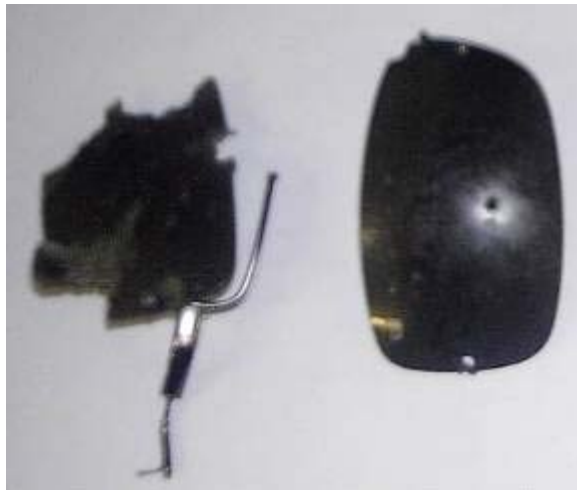
[The Victim's sunglasses were photographed later.]

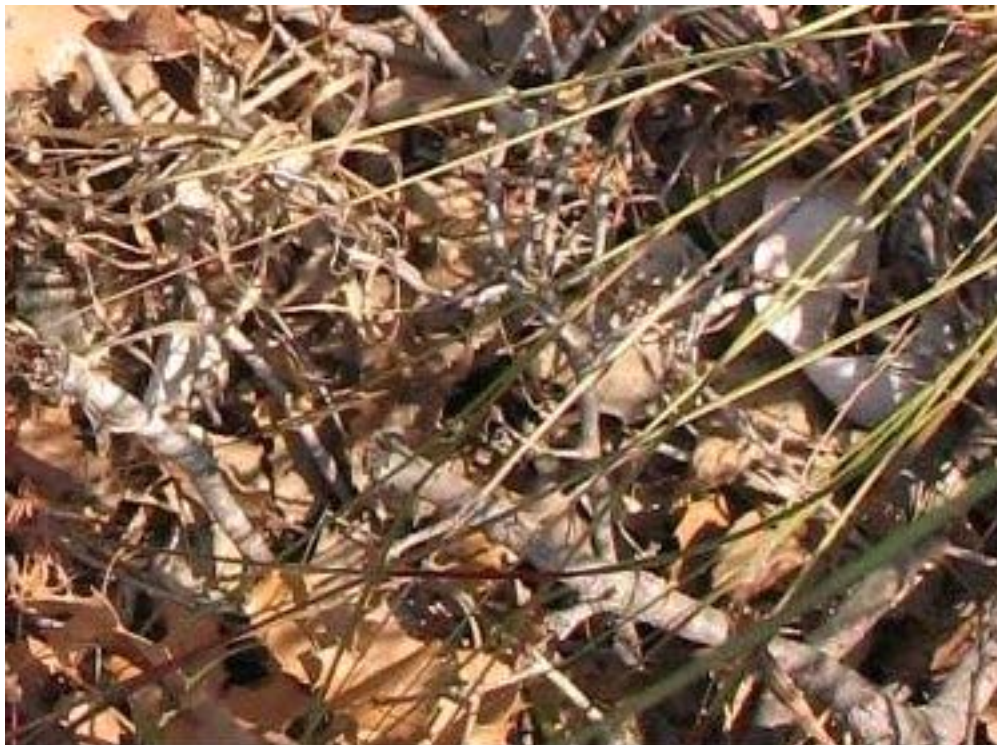
[An M77 ribbon can be seen on the right. The presence of this in the area implies that the same device killed the Victim.]

When the team arrived at the spot where the explosion took place, they found small parts of the cluster bomb that caused the death of the [European] NCO. No crater or signs of the explosion were found on the ground. There were blood stains in the area where the explosion took place and also 2.7 meters away, where the deceased's body was found. The area was surrounded by several unexploded cluster bombs.

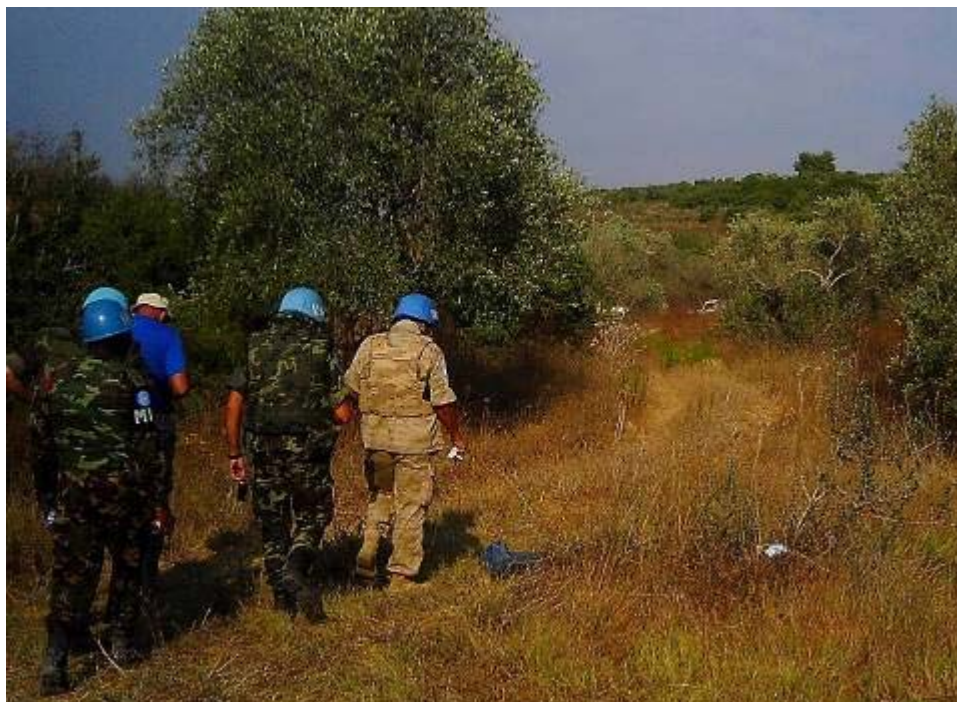
## Annex B: Scene of Incident

[This comprises a brief PowerPoint presentation that includes a picture of the investigators at the scene: at least one is not wearing any PPE – look for the floppy sunhat.]
